**Re: Transmittal of NPDES Stormwater Reconnaissance Inspection Report  
Earth Movement Activity at Parcel of Land, Rincón, Puerto Rico**

**NPDES Stormwater Reconnaissance Inspection**

**Earth Movement Activity at Parcel of Land**

**Inspection Date: October 4, 2018**

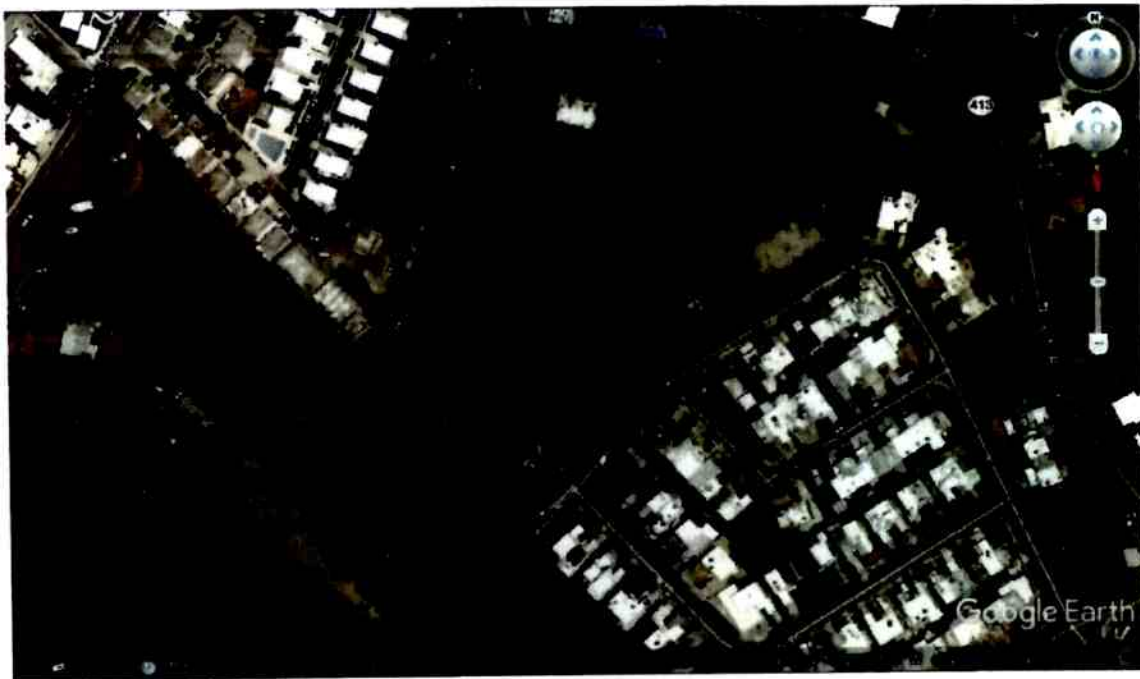
Figure 1

This Inspection Report includes findings and observations concerning the National Pollutant Discharge Elimination System ("NPDES") Stormwater Reconnaissance Inspection ("Inspection") conducted by José A. Rivera, Lead Environmental Engineer ("EPA Inspector"), Clean Water Act Team, of the United States Environmental Protection Agency's ("EPA") Caribbean Environmental Protection Division ("CEPD") at a "Parcel of Land" ("Site") located in Rincón, Puerto Rico, on Thursday, October 4, 2018.<sup>1</sup> **Figure 1** depicts the Site subject to the Inspection. **Figure 2** shows the land survey of the Site.

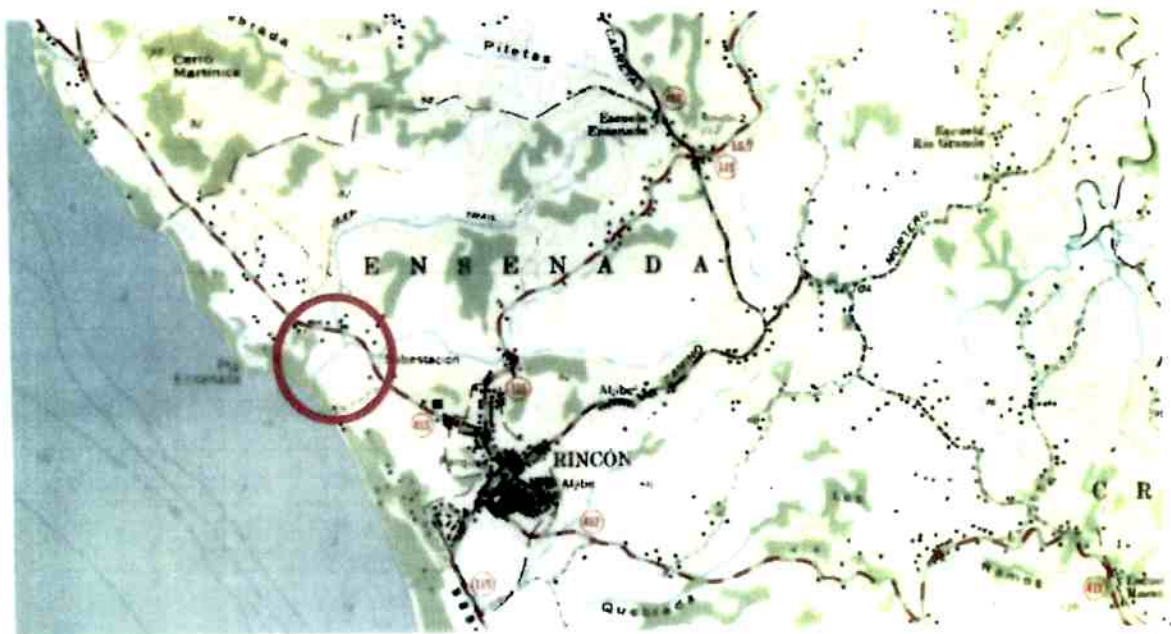
Figure 5

On October 8, 2018, the EPA Inspector evaluated the hydrological areas near the Site, and found that the unnamed creek receives stormwater runoff from the Site and other areas. **Figure 5** and **Figure 6** depict the unnamed creek, a portion of the hydrological areas associated with the unnamed creek, and the discharge location of the unnamed creek into the beach and Caribbean Sea. The source of information that the EPA Inspector used is found at "[http://gis.otg.pr.gov/apps/pr\\_map/](http://gis.otg.pr.gov/apps/pr_map/)".

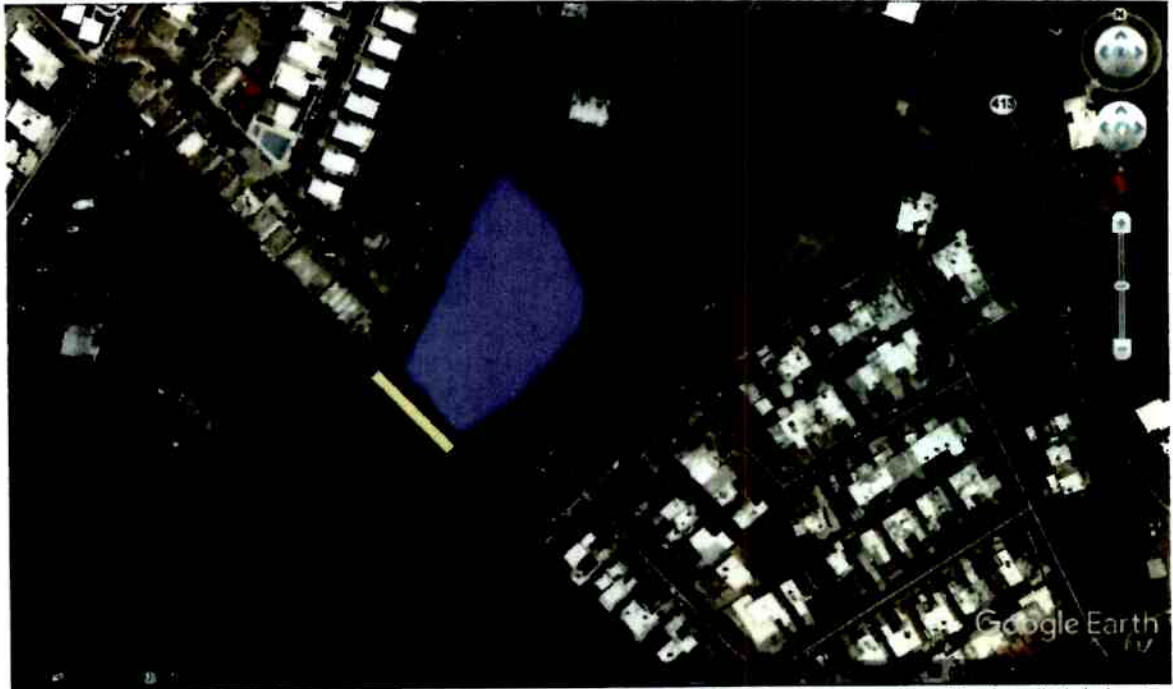
- a. Earth movement activity [soil clearing and grading (fill material)] at portions of the Site was observed. **Figure 7** depicts the approximately location of this observation. **Picture 1** and **Picture 2** depict portions of the Site where the earth movement was observed. This Report includes other pictures depicting the swale shown in **Picture 1**.
- b. The surface areas where the fill material was placed were not compacted and lacked erosion controls (**Picture 1** and **Picture 2**).
- c. Several soil piles were observed without any erosion controls at areas where the fill material was deposited.

Note: The area marked in yellow depicts a right of way (former train pathway). A stormwater collection ditch is located immediately above. This ditch conveys runoff into the unnamed creek.

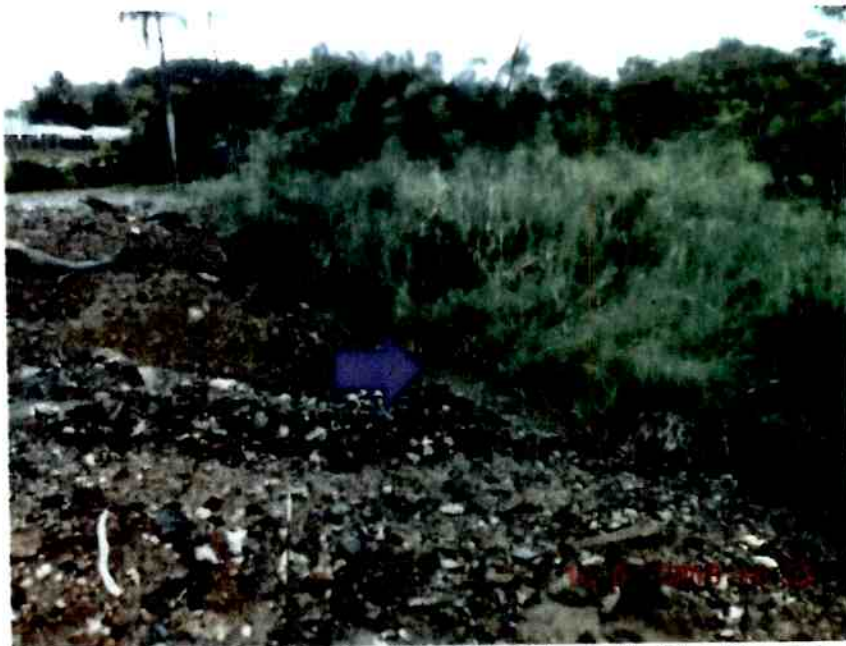
**Picture 3**

Note: See water touching the slope. This is the north side of the area where fill material was deposited.

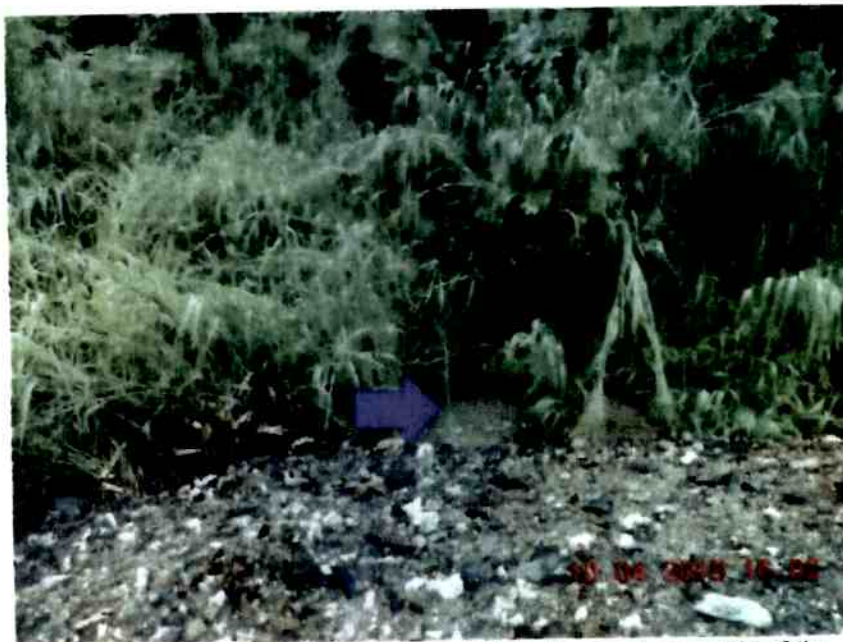
**Picture 4**

Note: See water touching the slope. This is the north-east side of the area where fill material was deposited.

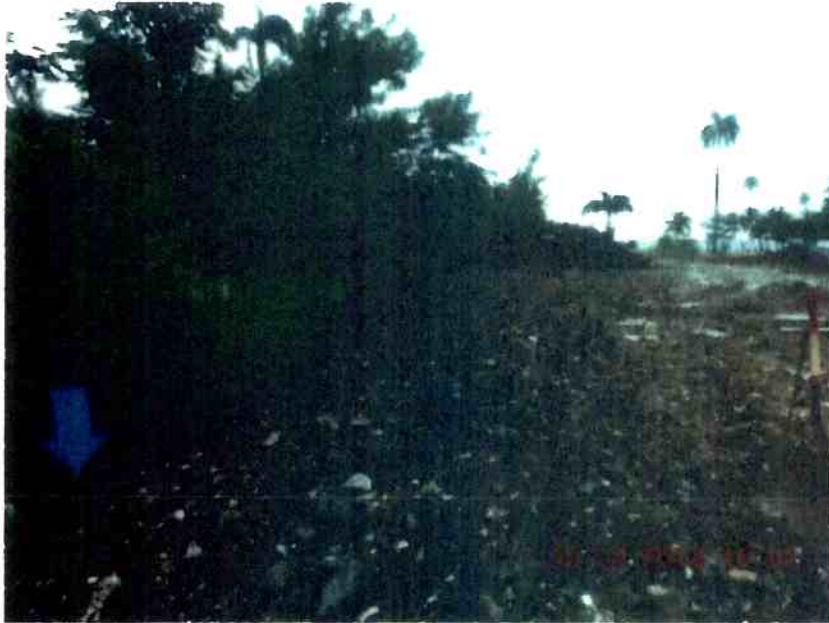
**Picture 5**

Note: See water touching the slope. This is the east side of the area where fill material was deposited. The creek runs along this side of the area where fill material was deposited.

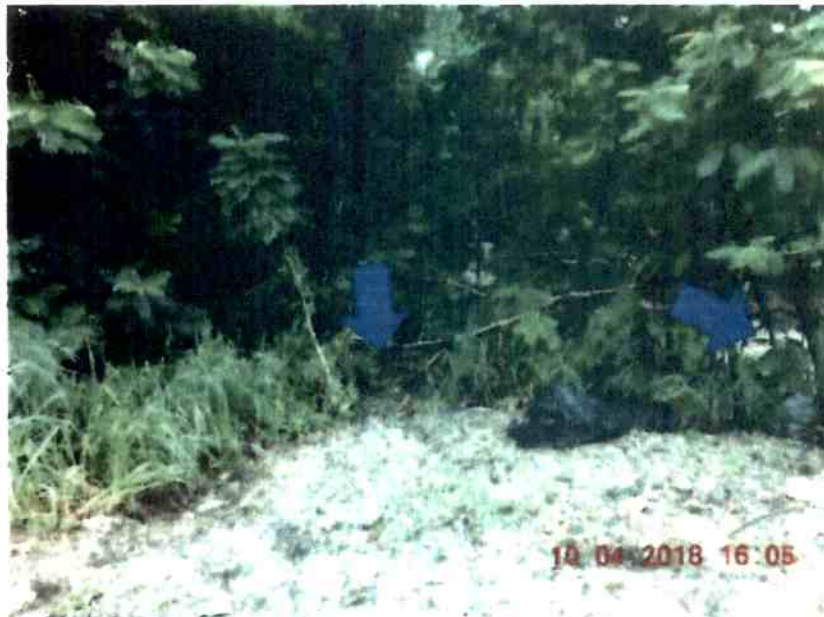
**Picture 6**

Note: See water touching the slope. This is the east side of the area where fill material was deposited. The creek runs along this side of the area where fill material was deposited. The flow of the creek is depicted on this picture.

- a. that water flow from the unnamed creek was touching slopes of the soil deposited at the Site;
- b. that a meeting at EPA was warranted to further discuss the findings of the Inspection, which he agreed to meet at CEPD on Wednesday, October 10, 2018;
- c. to bring the contractor that conducted the fill at the Site to the meeting; and
- d. provided information such as the EPA Inspector telephone number, CEPD's location, and email.

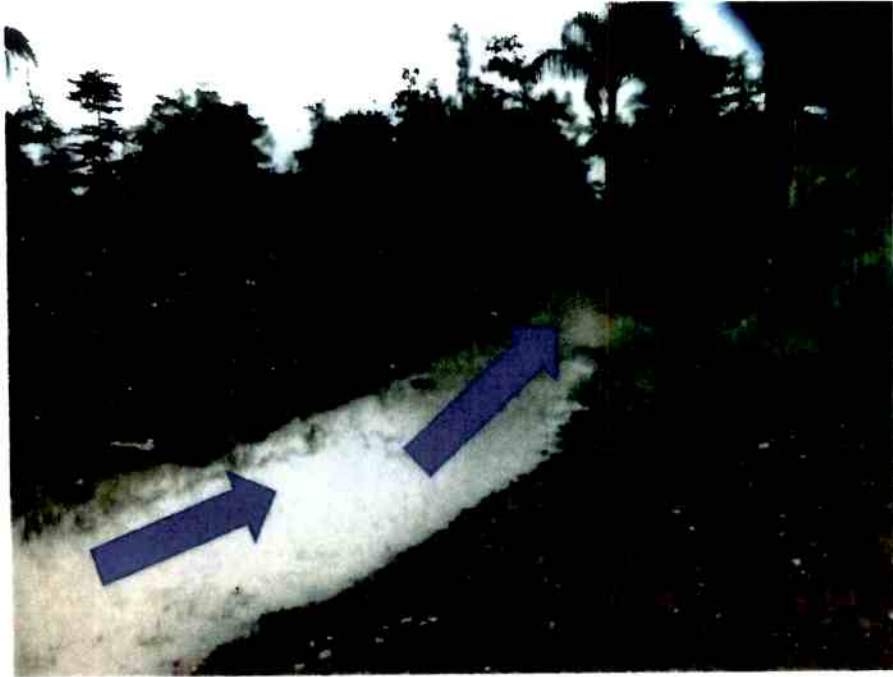
- d. The entrances to the Site from Road 413 and Project did not have erosion controls for off-site tracking of sediments.
- e. Perimeter runoff and erosion controls for retention of sediments were not observed.
- f. Most of the stormwater runoff from areas north of the right of way ultimately flow into a swale that conveys stormwater into the unnamed creek. See pictures included in this Report.
- g. Upon walking along the perimeter on the north and west areas, it was observed water from the unnamed creek touching the bottom areas of the slopes where the fill material was deposited. **Pictures 3 to 6** depict these observations.
- h. **Picture 1, Picture 7 and Picture 8** depict the swale located between the right of way and the south side where fill material was deposited.
- i. **Picture 9** depicts the intersection between the swale depicted in Pictures 1 and 7-8 and the unnamed creek.

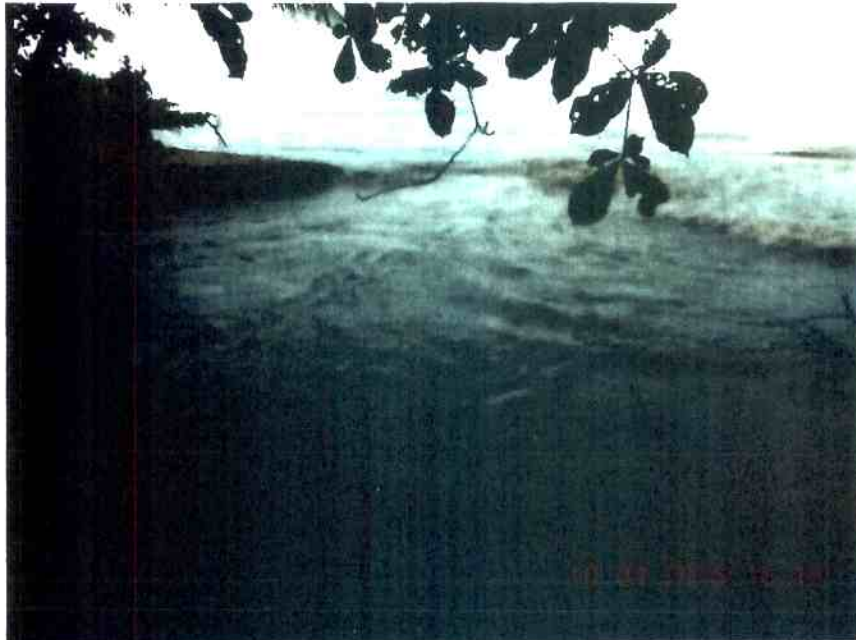
Picture 10

- j. The EPA Inspector observed the unnamed creek flowing into Caribbean Sea. **Picture 10** depicts the unnamed creek flowing into the Caribbean Sea.
